BIORAD GEENIUS HIV ½ CONFIMATORY ASSAY

SAMRC-HPRU

19 Sep 17

MTN regional meeting

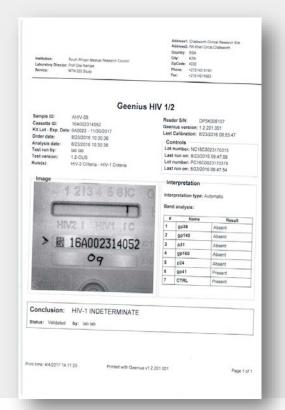
Result images

Name	Resul
1	gp36	Absent
2	gp140	Absent
3	p31	Absent
4	gp160	Absent
5	p24	Absent
6	gp41	Present
7	CTRL	Present

Conclusion: HIV-1 INDETERMINATE

- Possible sample contamination was suspected by the Medical Technologist who ran the sample.
- In order to ascertain contamination, the sample 09 from Chatsworth was sent to Tongaat site. It appears that the tech from Chatsworth contaminated survey 09 sample with one of the positive samples in the panel.
- This was verified when Tongaat reran their sample and the result was positive.
- When Chatsworth site re-ran sample 09 obtained from another site, the result was negative, run by a different Medical Technologist.
- Weekly maintenance was completed prior to running the sample and the lens checked by the site. This is done when the control is run weekly.

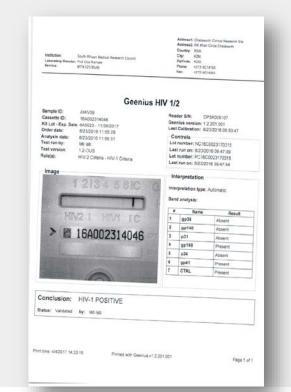
Archive Summary

Sample	Cassette ID	Kit Lot - Exp. Date	Test name	Rule(s)	Order date	Analysis	Status
AHIV09 Conclusio	16A00231404 6 on:	6A0023 - 11/30/2017 HIV-1 POS	Geenius HIV 1/2 (1.2-OUS)	HIV-2 Criteria - HIV-1 Criteria	118	8/23/2016 11:55:31	Validated
AHIV-09 Conclusio	16A00231404 7 nc	11/30/2017	Geenius HIV 1/2 (1.2-OUS) TERMINATE	HIV-2 Criteria - HIV-1 Criteria		B/23/2016 11:21:52	Validated
AHIV-09 Conclusion	2	11/30/2017	Geenius HIV 1/2 1 2-OUS) ERMINATE	HIV-2 Criteria - HIV-1 Criteria	8/23/2016 10:30:36	8/23/2016 10:30:38	Validated

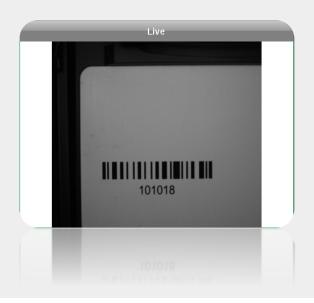
Real-time view:

- 1. Click the Instrument button in the toolbar to open the Instrument window.
- 2. In the Instrument window, select the
 <u>Maintenance tab</u>. On the right-hand side
 of this tab, a small "Live window" provides
 a real-time view of the surface of the
 image capture zone.
- 3. Make sure this surface is clean and free of stains and foreign matter. If it is not, clean as described below.
- 4. In addition to this visual check, the system performs an automated verification of this area during the calibration process.
